Endodontic and Surgical Management of Iatrogenic Root Injury Caused by Orthodontic Miniscrew Placement: A Case Report

Article Type: Case Report

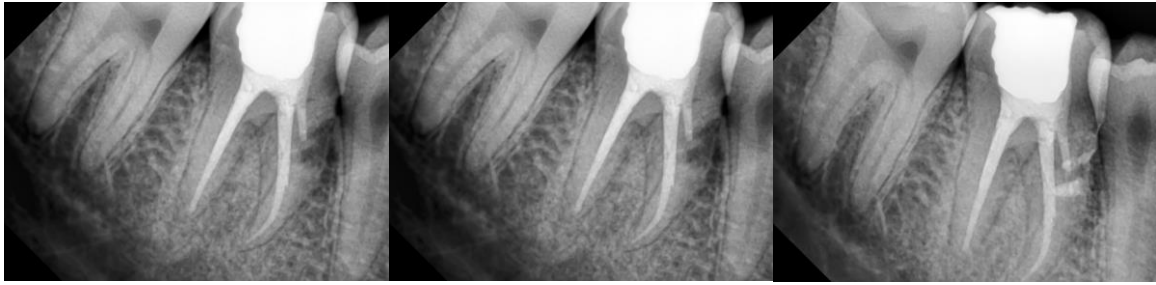
Figure 3. Periapical views of tooth #30 following surgical removal of the miniscrews and MTA placement

powder (SureOss, Hans Biomed, Daejeon, Korea) and a resorbable membrane (SureDerm, Hans Biomed, Daejeon, Korea). The flap was repositioned and sutured ([Figure 3](#)).

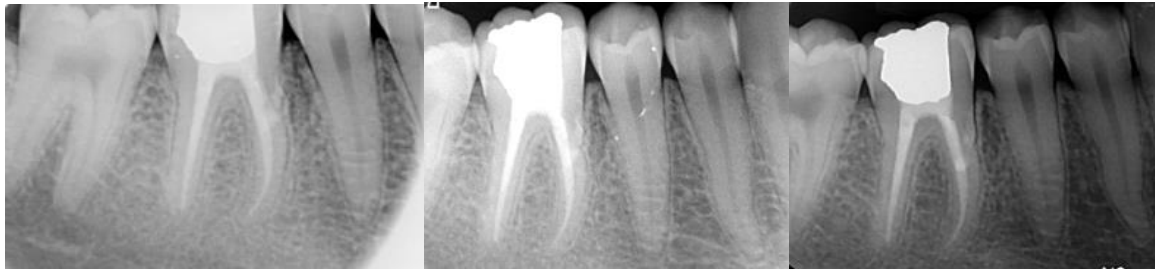
Figure 4. Six, 12 and 24-month follow-up of tooth #30

After the follow-up of 6, 12 and 24 months, the patient was symptom-free and significant bone healing was observed ([Figure 4](#)).
