Full Mouth Reconstruction of a Patient with Worn Dentition: A Clinical Report

Abstract

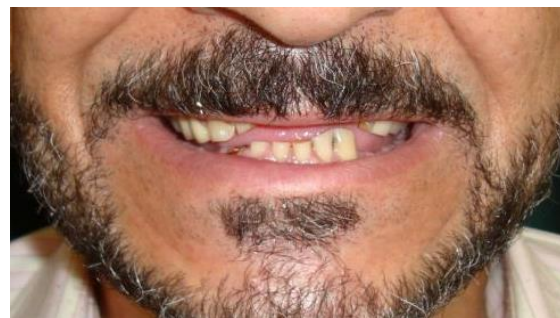
Figure 2- Patient's smile before treatment

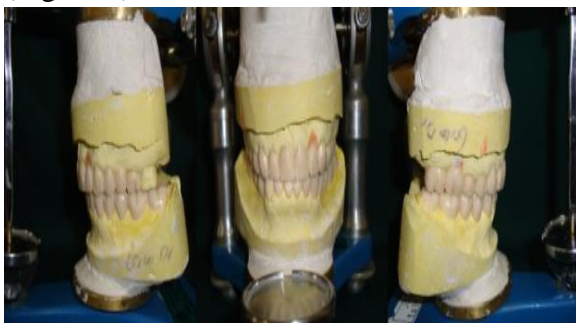
Figure 3- Diagnostic wax-up

The third treatment plan was selected and the treatment was started with a provisional restoration. Initially, the molding procedure was accomplished with irreversible hydrocolloids (Tropicalgin, Zhermack, Rovigo, Italy) and dental compound (Kerr, Orange, CA, USA). The plaster casts were prepared using dental stone (Elite stone, Zhermack, Rovigo, Italy). The casts were mounted in a semi-adjustable articulator (Dentatus, Spånga, Sweden) with a face bow in centric relation with restored VD using a base and wax rim in mandibular jaw and polyvinyl siloxane registration material (Occlufast Rock, Zhermack, Rovigo, Italy). The OVD was increased by approximately 7 mm in the mouth as the edges of the intact canines (right maxillary and left mandibular) made a 1mm overbite. The interocclusal rest space was measured to be 2mm in this state (Figure 3).

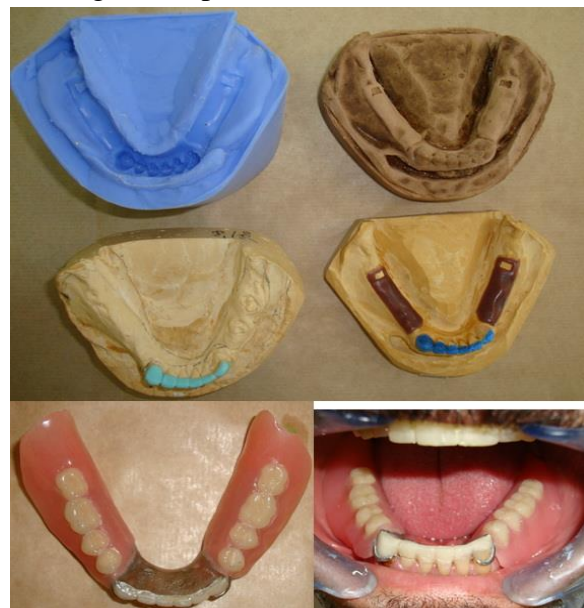
Figure 4- Temporary mandibular prosthesis (classic removable partial denture with metal framework was fabricated on duplicated cast after relief and block out)

A mandibular partial overdenture was constructed, which restored the patient's OVD as mentioned (Figure 4). The overdenture established the correct assumed

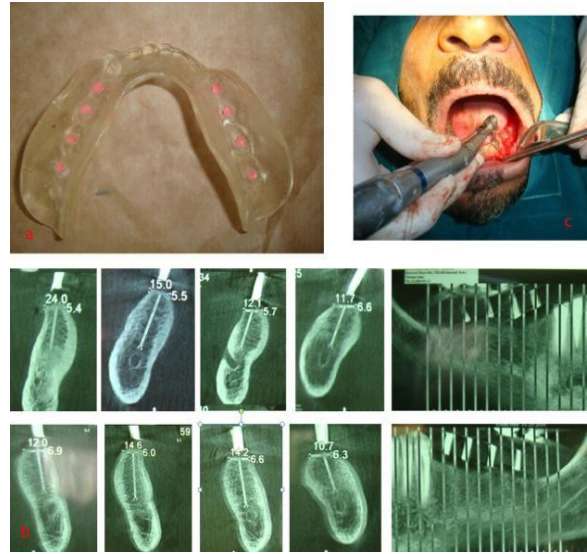
Figure 5- Radiographic template fabrication and use. a-Radiographic template with gutta-percha in place. b-CBCT images of the desired implant site. c- Implant installation with surgical template.

implant placement began. Teeth #4, 5, 8, 9, 14, 22, 23, 24, 25 and 26 underwent endodontic treatment. Teeth #12 and 27 underwent retreatment. The mandibular overdenture was duplicated with laboratory polyvinyl siloxane (Zhermack, Rovigo, Italy) and the silicon index was poured with a transparent acrylic resin (Acropars, Tehran, Iran). The ideal location of assumed dental implants was drilled with a milling machine (Metalor MP300, Metalor Technologies Ltd., Birmingham, UK) and filled with gutta percha (Aria Dent, Tehran, Iran) as shown in Figure 5. The patient was referred for Cone Beam CT scan (CBCT)(Picasso Tio E-Woo technology, Gyeonggi-DO, South Korea) imaging with this radiographic template (Figure 5). After ensuring that no correction was needed, implant placement surgery was scheduled. The radiographic template was converted to the surgical template by removing the gutta-percha. The surgical procedure was performed by using the surgical template. No bone graft was needed. Fixtures were selected according to the cone beam computed tomography data. Four fixtures with 3.8mm diameter and 12mm length and two fixtures with 4.5mm diameter and 10mm length were selected (Xive, Dentsply, Steinzeugstr, Germany). The wide fixtures were placed at the location of teeth #18 and 31 and the regular fixtures were installed in the locations of teeth #19, 21, 28 and 30 and allowed to heal (Figure 5).

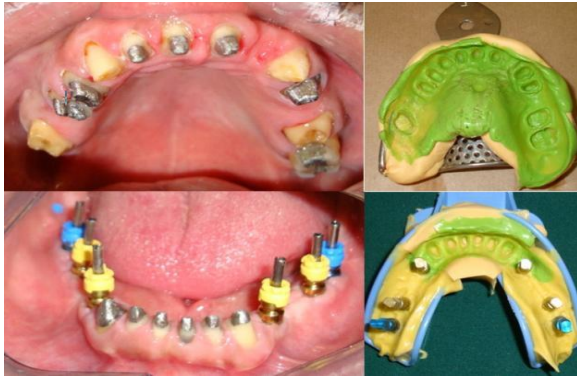
Figure 6- a-Final tooth preparation in upper jaw b-final impression in upper jaw c-final tooth preparation and impression coping in place in lower jaw d-final impression of lower jaw

After two months, the final phases of treatment were started. During these two months, the intracanal post and cores of the endodontically treated teeth (teeth #4, 5, 7, 8, 9, 12, 22, 23, 24, 25, 26 and 27) were fabricated by the direct technique and cast with Sankin dental alloy (Dentsply, Tokyo, Japan). The cast cores were cemented with Panavia F2 resin cement (Kuraray Dental, Tokyo, Japan). As the posts were cemented and the fixtures were uncovered surgically, a new fixed temporary restoration was fabricated. Following fixed temporary restoration, final tooth preparation with shoulder-beveled and chamfer margin configuration was performed and the final impression with polyvinyl siloxane material (Elite HD, Zhermack, Rovigo, Italy) was made (Figure 6). Final casts were poured and mounted in a semi-adjustable articulator (Dentatus, Finspångsgatan, Sweden) (Figure 7).

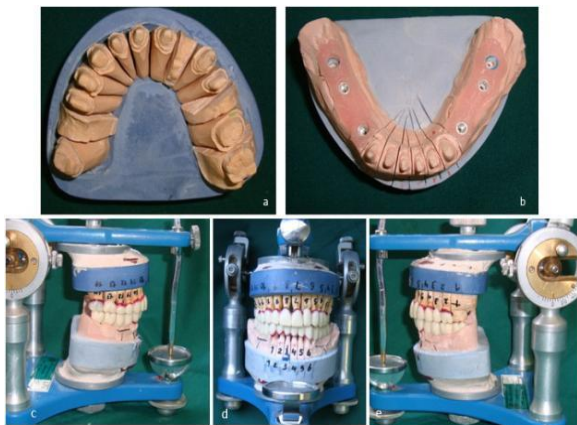
Figure 7- a- Final upper cast b- final lower cast c- mounted cast with full contour wax-up

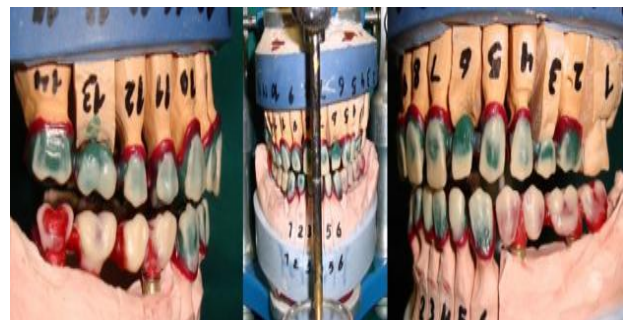
Figure 8- Framework wax-up for final MCR a- right lateral view b-frontal view c- left lateral view

The laboratory procedure including ditch, full contour wax-up and indexing were done with respect to the previous temporary restorations and the occlusal plane. Cement-retained dental implant abutments (Xive, Dentsply, Steinzeugstr, Germany) with proper length, diameter, angulation and gingival height were selected and prepared with a milling machine (Metalor MP300, Metalor Technologies Ltd., Birmingham, UK) to create enough space for the final restoration. Framework wax-up for metal ceramic restorations was accomplished (Figure 8) and cast with Sankin dental alloy (Dentsply, Tokyo, Japan)(Figure 9).

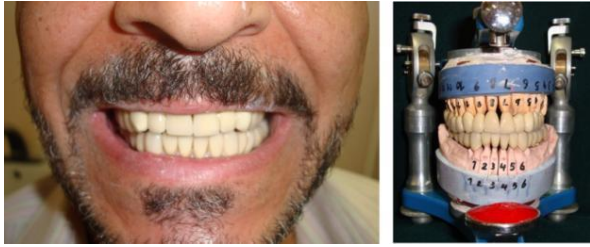
Figure 10- Final restoration. a- Final restoration in articulator b- Smile

The framework try-in and adjustments were done in the mouth. Ceramic (Ceracomco, Dentsply, Burlington, NJ, USA) and provisional casts of provisional restorations were made. Once the ceramic was applied, the necessary adjustments were made and the restorations were cemented with TempBond (Kerr, Rastatt, Germany) after staining and glazing (Figure 10). Before cementation, the abutments were tightened with a torque wrench to 30Ncm. After one month of follow-up, the restoration was removed and cemented with poly carboxylate cement (Durelon, 3M, St. Paul, MN, USA). No signs or symptoms of gingival inflammation, periodontal disease, tooth mobility, ceramic fracture or component failure were detected. An occlusal splint with hard acrylic resin (Acropars, Tehran, Iran) was fabricated for use six to eight hours daily or at night to protect the restoration against possible future para-function.
