A Modified Radiographic Technique to Confirm the Attachment Seating in Auricular Prostheses

Objectives Implant-retained maxillofacial prostheses have proven to be more successful than conventional adhesive-retained prostheses. Implants enhance prosthesis stability and retention through retentive attachments. However, a faulty abutment-implant interface in terms of complete seating and passive fit could be responsible for mechanical and/or biological complications. This case report describes a simple imaging method to check this adaptation.

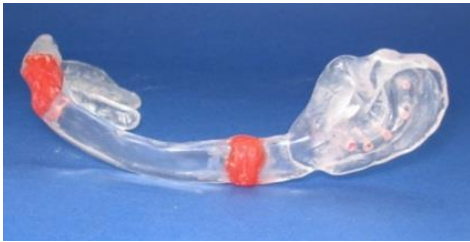
Figure 1- Acrylic resin ear stent and extra-oral acrylic resin bar.

2- A wax pattern of the lost ear was formed based on the shape and position of the right ear. In order to assure a symmetrical ear pattern, a try-in session was planned. An inter-occlusal wax record was made and then joined to the left ear wax model with an extra-oral wax bar. The left ear wax pattern, inter-occlusal wax record, and extra-oral wax bar were processed separately with heat-curing clear acrylic resin (Orthodontic acrylic; Great Lakes Orthodontic, Tonawanda, NY) (Figure 1).

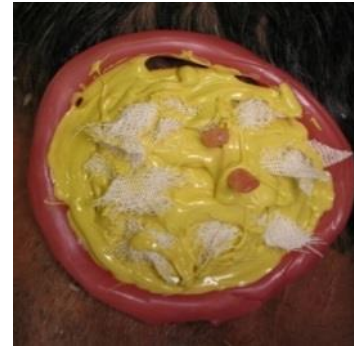
Figure 2- Final impression of the ear taken with elastomeric impression material.

5- Three weeks later, final impression was made using two open tray impression copings (Straumann AG, Waldenburg, Switzerland) and elastomeric impression material (Affinis, Coltene Whaledent Inc., Mahwah, NJ) (Figure 2). The hair around the ear was coated with petroleum jelly (Vaseline, Chesebrough-pond's USA Co, Greenwich, CT). After removing the impression, the implant analogs (Straumann AG, Waldenburg, Switzerland) were screwed to the impression copings, and the impression was poured

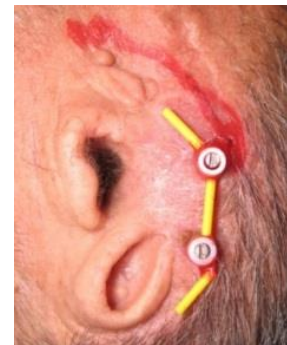
Figure 3- Try-in of wax pattern of bar attachment

6- Two UCLA plastic abutments were connected with mid bar and two terminal cantilever bars. The position of the bars was corrected according to the original wax model and then the wax pattern of the bar attachment was tried on (Figure 3). After confirming the desired seating of the attachment and ear prosthesis wax patterns, the bar attachment was cast with Ni-Cr alloy (4all®; Ivoclar Vivadent, Schaan, Liechtenstein).

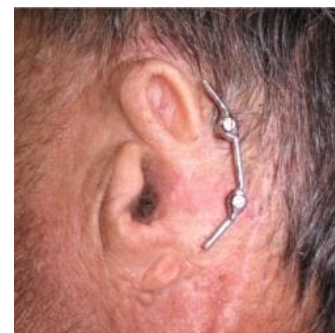
Figure 4- Cast bar attachment screwed to the implants

7- To ensure complete seating and passive fit of the suprastructure (bar attachment), it was screwed to the implants (Figure 4) and a modified posterior-anterior radiograph was taken. In this imaging technique, the patient's head was bent 15 degrees downward compared with the standard posterior-anterior radiograph. Before proceeding to the next step, the complete seating of the suprastructure was confirmed radiographically (Figure 5).

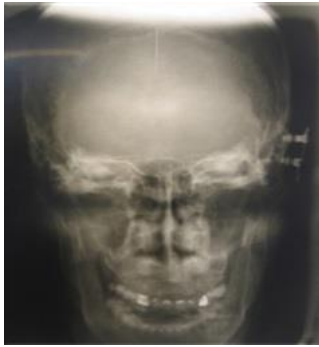
Figure 5- Seating of bar attachment confirmed radiographically

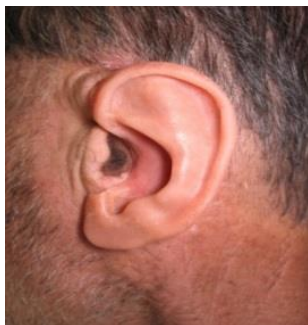
Figure 6- Final auricular prosthesis delivered.

9- At the delivery session, the bar attachment was screwed to the implants. After inserting the plastic clips on the inner surface of the prosthesis, the prosthesis was delivered (Figure 6). Necessary hygiene instructions were given to the patient.
