Repeated Abutment Screw Fracture during Implant-Supported Prosthesis Fabrication Due to Internal Fixture Defect: A Case Report and Management Strategy

Soraya Soleimani^a, Nariman Nikparto^b, Reza Eftekhar Ashtiani^a

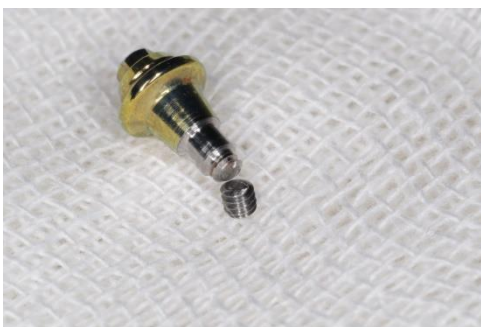
Figure 1: Clinical photograph showing the fractured abutment in situ at site 8 in the maxilla.

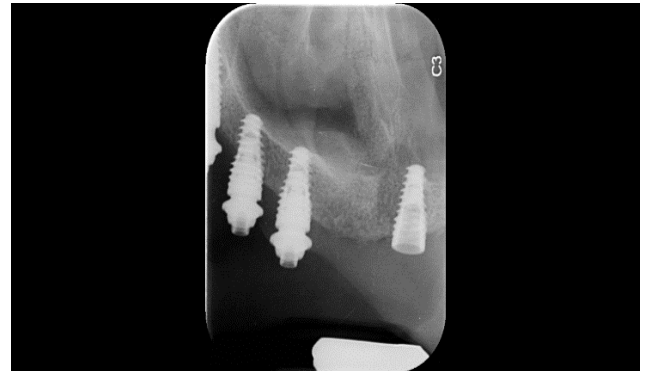
Figure 2: Periapical radiograph demonstrating the fractured abutment screw within the implant at site 8.

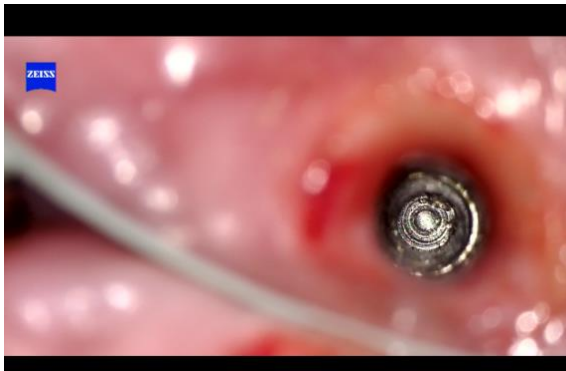
internal surface of implants. (A) Impression of the internal surface of a normal, intact implant. (B) Impression of the internal surface of our patient's implant, showing visible defects.
