Re-attachment of a Fractured Maxillary Central Incisor: A Case with Two Years Follow-up

Article Type: Case Report

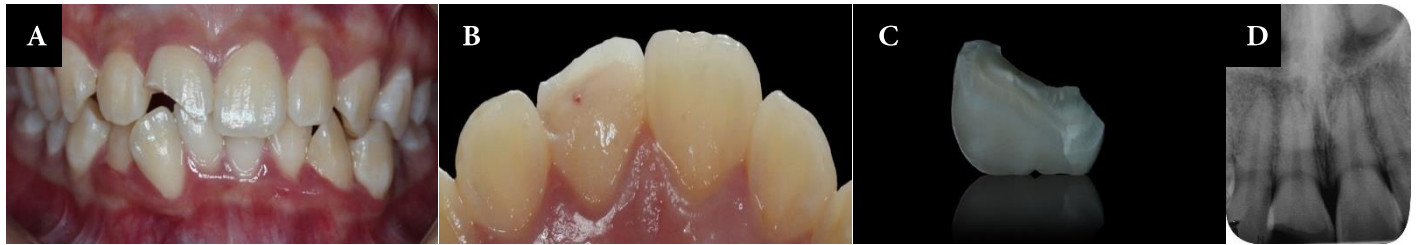
Figure 1. A) Frontal view showing the fractured tooth #11; B) Palatal view showing a small pulp exposure of approximately 1 mm; C) The fractured fragment of tooth #11 brought in by the patient; D) Pre-operative periapical radiograph showing the level of the fractured crown; no sign of periapical infection was noted

Extraorally, there was no apparent sign of trauma to the soft tissues. Intraoral clinical examination revealed a complicated crown fracture (incisal one-third) of the right maxillary central incisor (Figure 1A), with a small pulp exposure of approximately 1 mm (Figure 1B). Tooth #11 was not tender both on palpation and percussion, and responded to cold test Endo-Frost Cold Spray (Roeko, Langenau, Germany) and electric pulp test Digitest™ Pulp Vitality Tester (Parkell Inc, New York, USA). The remaining maxillary and mandibular anterior teeth were all intact. All anterior maxillary teeth were tested for pulp sensibility tests and they all responded to cold and electrical pulp tests. Soft tissue around the affected tooth and adjacent teeth was normal without any swelling, abscess, draining sinus or loss of stippling of gingiva. There was no

bleeding on probing and the periodontal probing depth was within normal limit (2-3 mm) with no mobility. The crown fragment was in good condition and it fitted reasonably well on the fractured tooth (Figure 1C). Periapical radiographic examination revealed horizontal fracture line on the crown of the tooth, complete root development, closed apices, no periapical pathology, and absence of root or alveolar bone fractures (Figure 1D). After history taking and examination, the patient and the mother were provided with several treatment options and associated benefits and disadvantages of each. They opted to have the crown fragment re-attachment with direct pulp capping. The procedure was explained to them and informed consent was obtained.

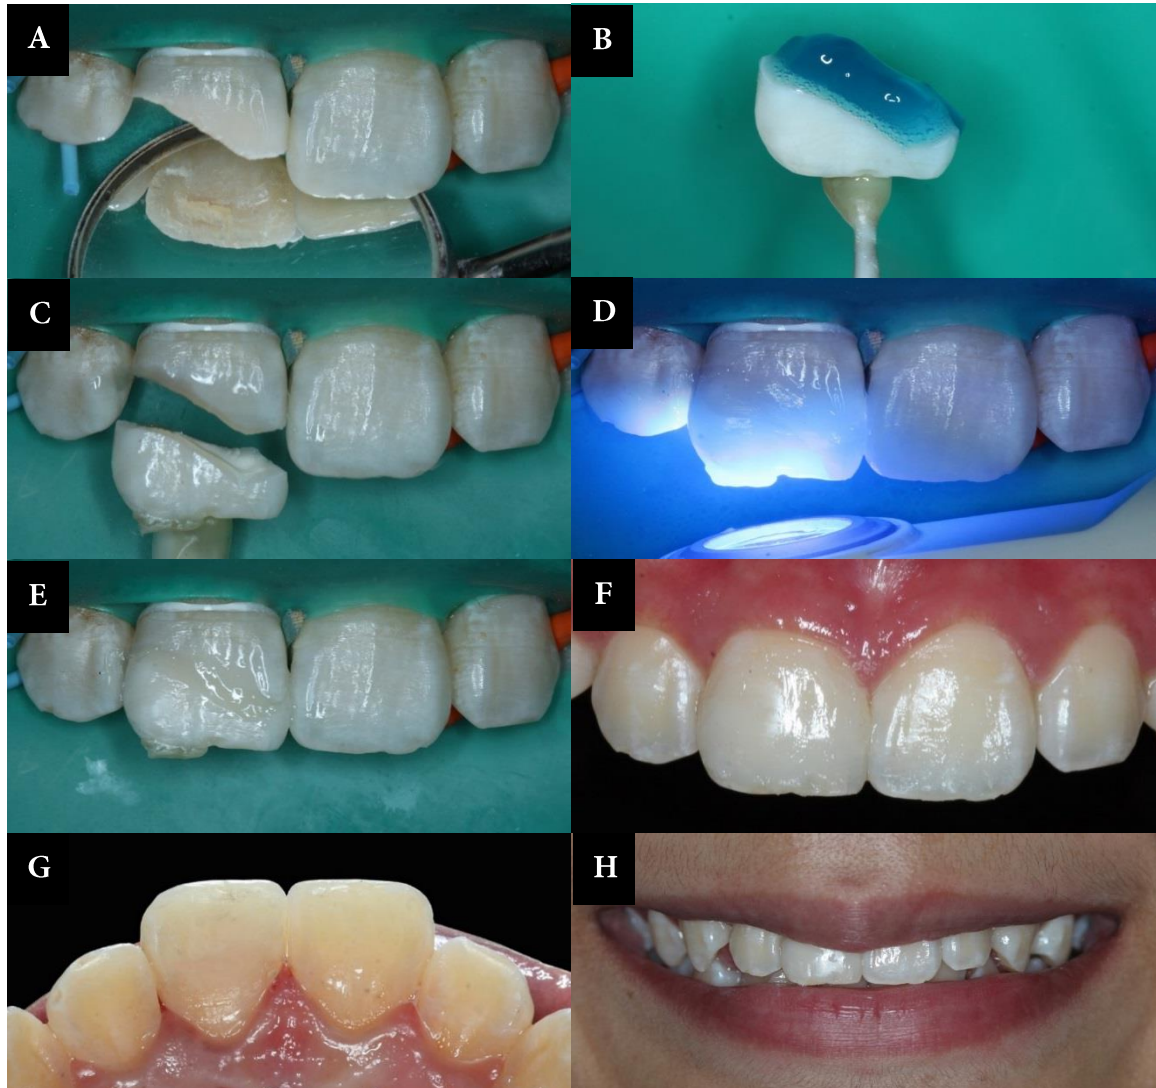
Figure 2. A) Operating field isolation by a rubber dam (multiple isolation) and CaOH placed; B) Fragment attached to a “pick-and-stick” device and etched; C) Fractured fragment repositioned exactly in its original place; D) Flowable composite resin was injected between the tooth and fragment and light-cured for 20 seconds on each surface. This effectively attached the fragment in place; E) A V-shaped external ‘double chamfer’ margin of 1mm coronally and apically to the fracture line was created using a diamond round bur. A transparent A2 shade of composite resin is then applied and cured along the fracture line; F) Frontal view of tooth #11 after polishing of the composite surface; G) Palatal view of tooth #11 after polishing of the composite surface; H) Smile view of tooth #11 after the completion of re-attachment procedure

The treatment was initiated by administering one cartridge of local anesthesia (2% Scandonest with 1:20,000 levonordefrin) *via* buccal infiltration. The affected tooth and adjacent teeth were isolated with rubber dam (Figure 2A). The pulp exposure was carefully irrigated with alternate solutions of normal saline and 0.12% chlorhexidine gluconate (PerioGard Oral Rinse; Colgate, Canton, MA, USA). Direct pulp capping was performed by applying self-hardening calcium hydroxide (CaOH) (Dycal; Dentsply Caulk, Milford, DE, USA) on the exposed pulp (Figure 2A). A layer of resin-modified RMGIC (Vitrebond; 3M Espe, St Paul, MN, USA) was placed over the pulp capping material and then photo polymerized for 40 sec. The remaining tooth structure was acid etched using 37% orthophosphoric acid (Ultra-Etch; Ultradent, SJ, UT, USA) for 15 sec. The acid was removed by rinsing with water, and the surface was gently dried with cotton pellets. A bonding agent was applied on the tooth structure with an ethanol-based total-etch adhesive system (Adper Single Bond Plus, 3M ESPE, St. Paul, MN, USA) and was cured with visible light for 10 sec [12]. Most attention was given to the dentin bonding agent so as not to cause any thickening on the surface.

Tooth fragment was stored in distilled water for 30 min before being repositioned to rehydrate it [13]. To ease the handling, it was secured by a “pick-and-stick” device (the palatal surface of the fractured segments was glued with to a handbrush using sticky wax (Figure 2B). The fractured surface was treated with 37%

phosphoric acid gel for 30 sec (Figure 2B), followed by delicate rinsing [12]. The adhesive system was then applied to the etched surface and was light cured for 10 sec [12]. The fractured segment was then accurately placed on the tooth, paying special attention to the fit between the segments (Figure 2C). When the original position had been re-established, the flowable composite resin (Tetric Flow; Ivoclar Vivadent, Schaan, Liechtensien) was applied to the fracture surfaces of both parts, spread over the surface with a dental probe, and the fragments were reattached to their places. The overflowing resin composite was removed and cured with visible light for 20 sec from both the labial and palatal surfaces (Figure 2D) [14]. Subsequently, 1 mm coronal and apical to the fracture line, a

V-shaped external ‘double chamfer’ margin was created using a diamond round bur (Figure 2E). The double chamfer was etched, applied with adhesive resin and restored with a composite resin (Filtek Z350 XT, A2 shade, 3M ESPE, St. Paul, MN, USA). The composite was cured for a time of 20 sec per increment [15].

The margins were polished with diamond burs and a series of Sof-Lex disks (3M ESPE, St. Paul, MN, USA) and polishing paste (Diamond Polish; Ultradent Products, SJ, UT, USA) (Figures 2F-H). The occlusion was checked and adjusted, and the patient was dismissed after receiving instructions to avoid exerting heavy function on this tooth. The patient and the patient’s mother were informed that the re-attachment line might be visible, and, if

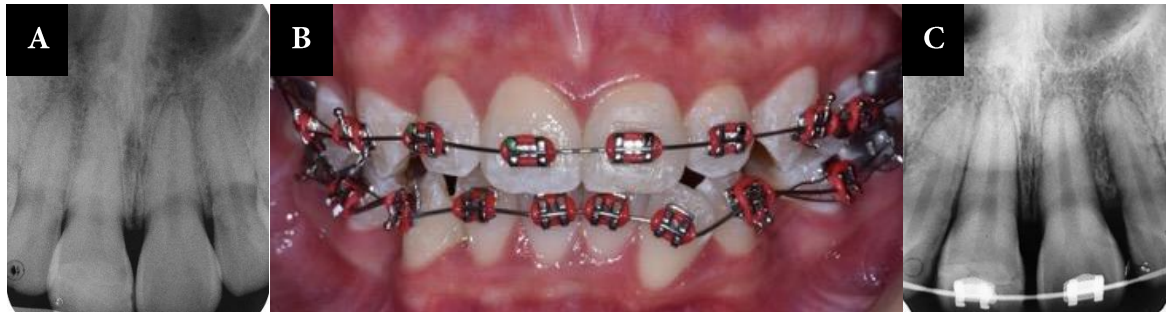
Figure 3. A) Radiographic image of the tooth after six-month showing no sign of periapical infection; B) Two-year follow-up showing tooth #11 with surrounding healthy soft tissues. Patient had undergone orthodontic treatment at this time to improve her occlusion; C) Radiographic image of the tooth after two-year review. No sign of periapical infection was detected

necessary, this could be managed in future visits. The patient was reviewed after one week, one month, six months (Figure 3A) and two years after treatment. After two years, the restoration was functional and aesthetically acceptable. Fixed orthodontic bracket was attached on labial surface of tooth #11. Tooth #11 was found to be vital by pulp sensibility tests, and there was no sign of periodontal or periapical pathology in the periapical radiograph (Figure 3B, 3C).
