Accidental High Voltage Electrocution: a Case Report

Case Report: This case report discusses the injuries sustained by a young adult, due to accidental contact with high tension wire.

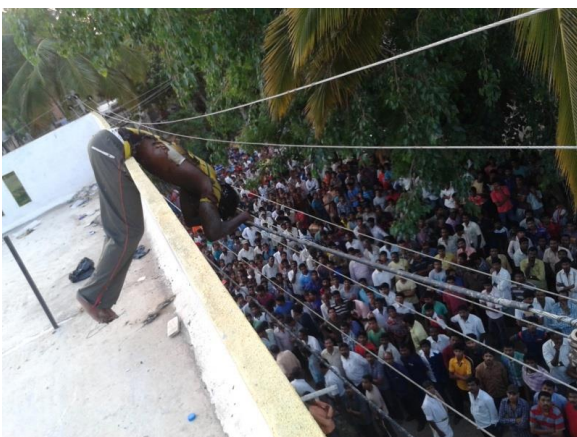
Body of a 21-year old male was brought to the mortuary of JSS Medical College, Mysuru. The victim accidentally came into contact with a high tension wire which was passing by the side of his house terrace (Figure 1).

Fig. 1. The scene of occurrence and position of body.

As per Indian Electricity Rules 1966, clearance for construction of buildings adjacent or beneath the high voltage line is issued based on the maximum sagging of the electric lines and vertical clearance between the highest point of the building and the electric lines. While the clearance distance between the building and electric line should be 3.7 meters for lines carrying power up to 33 kV and for lines carrying power above 33 kV, a distance of 0.3 m will be added for every additional kV (4, 5).

The distance between high tension power line and the house as seen in figure 1 in the present case, was less than 1 meter which is in clear violation of rules.

The High tension wire in this case had a protective plastic pipe casing. Even with protection the victim was electrocuted. The plastic casing may have been weakened because of elements of nature.

Present case occurred as a result of flouting of building rules with respect to overhead electric wires which reflects poor town/city planning. This case warrants the need of underground electric cables or proper insulation of overhead electric wires.

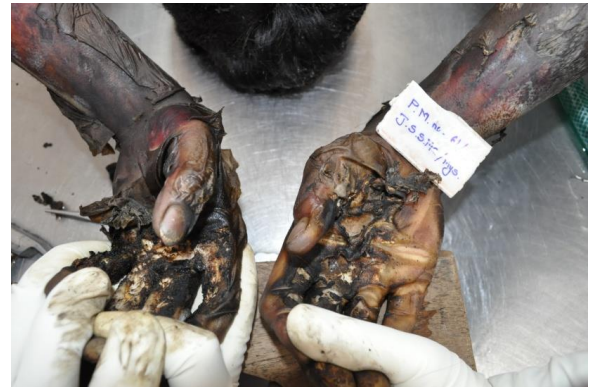
On external examination, lesions of entry in the form of deep burns exposing tendons with charring of edges were seen over right and left palm (Figure 2).

Fig. 2. Entry lesions.

Histopathology of entry and exit marks showed partially separated dermis and altered dermal papilla with streaming of nuclei. The skin over crocodile flash burns showed thinning with focal separation of epidermis with nuclear streaming.

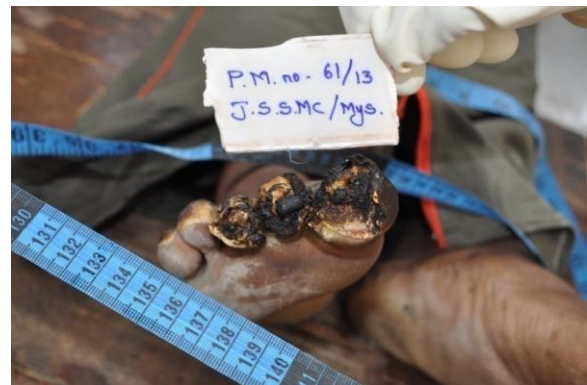
Exit lesions in the form of deep burns exposing tendons with charring of edges were noted over the sole of right and left foot (Figure 3 and 4).

Fig. 3. Exit lesion over the sole of right foot.

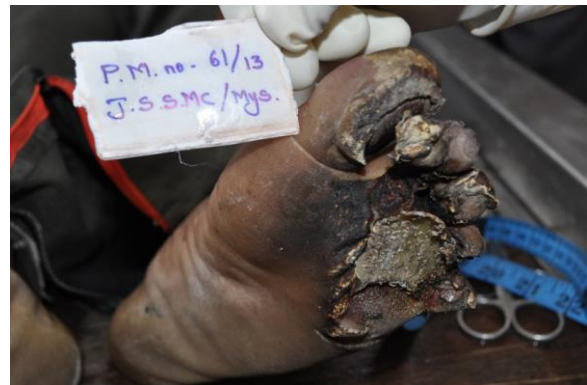
Fig. 4. Exit lesion over sole of left foot.

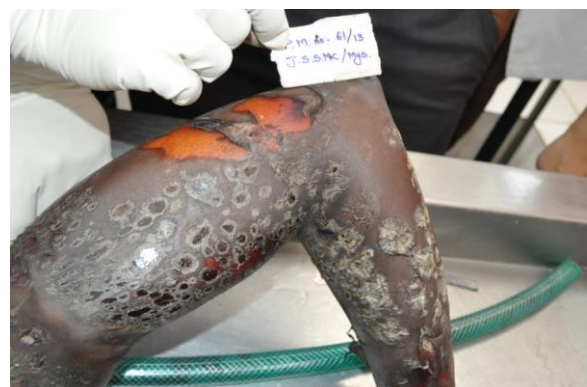
Multiple punched out lesions (Crocodile flash burns) were present over front of chest and both upper limbs (Figure 5).

Fig. 5. Crocodile flash burns over the right upper limb.

Cause of death in this case was opined as death due to electrocution. The crocodile flash burns seen in the victim's body is as a result of high voltage current which can result in sparking over many centimetres.
